Abnormal Chirp or Squeak Noise From High Pressure Fuel Pump

Service Category Engine/Hybrid System

Section Fuel System

YEAR(S)	MODEL(S)	ADDITIONAL INFORMATION
2013 - 2016	FR-S

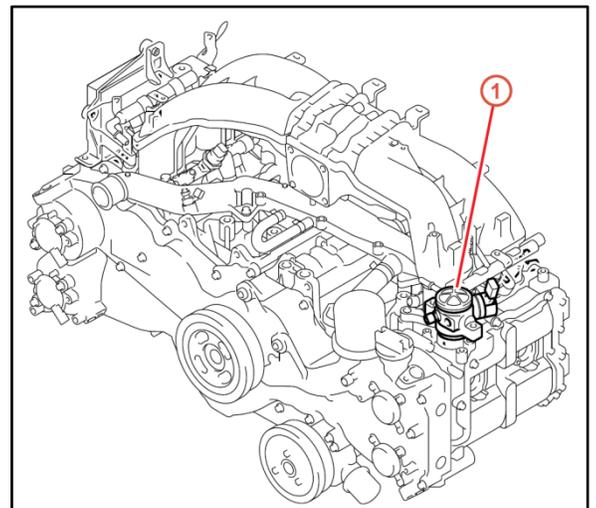
Figure 1.

1. Road test the vehicle for at least 10 minutes so that the engine is fully warmed-up.
2. While the engine is idling, listen for abnormal noise from the high pressure Fuel Pump Assembly.

- A mechanical ticking noise from the high pressure Fuel Pump Assembly is normal during direct injection system operation.
- This bulletin should **ONLY** be performed if an abnormal high pitch chirp or squeak noise from the high pressure Fuel Pump is verified.

Fuel Pump Assembly (for High Pressure)

4. Replace the high pressure Fuel Pump Assembly.
