SUBARU

SERVICE BULLETIN

NUMBER: 12-139-12

SUBJECT: Specification Change to Front Bumper
 Fascia Mounting Brackets

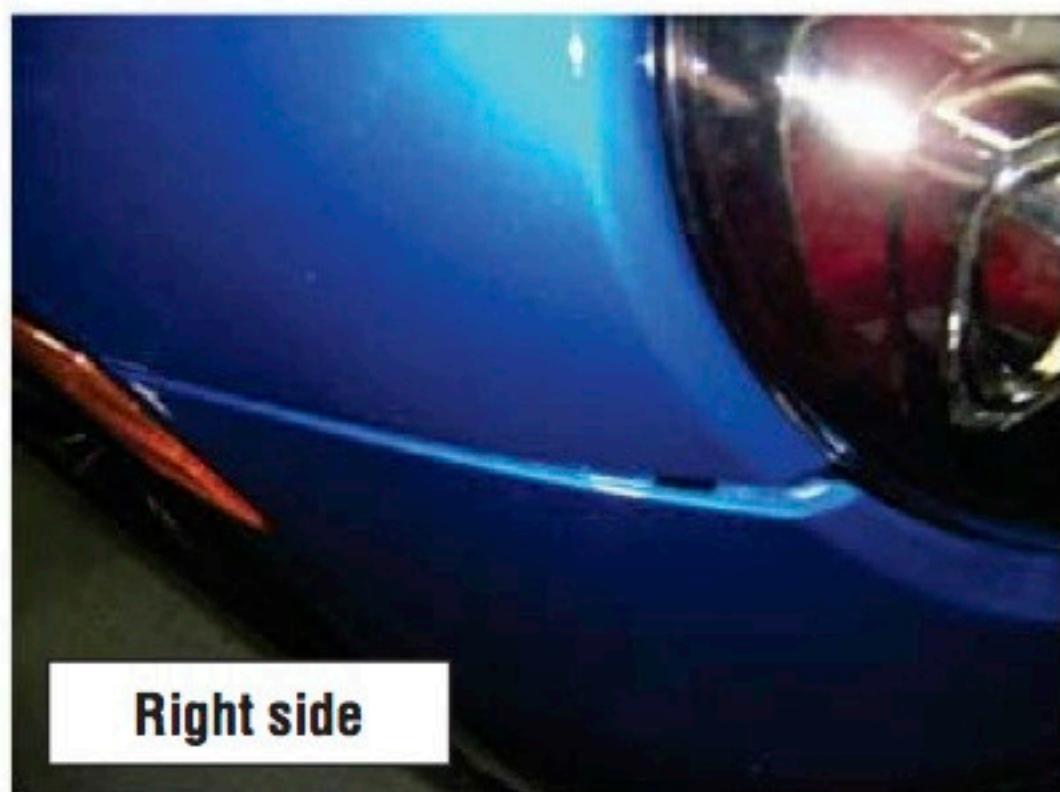
Right side

The following photos show examples of incorrect fit of the front bumper fascia when being insufficiently retained by the corner mounting brackets or misaligned with the bracket's mounting tab. In these examples shown below, an excessive fender gap is the result. This condition may occur on bumpers with no damage from impact and should not be confused with bumper pop-out as a result of any impact. Bumpers with impact damage may require replacement in order to be properly secured.

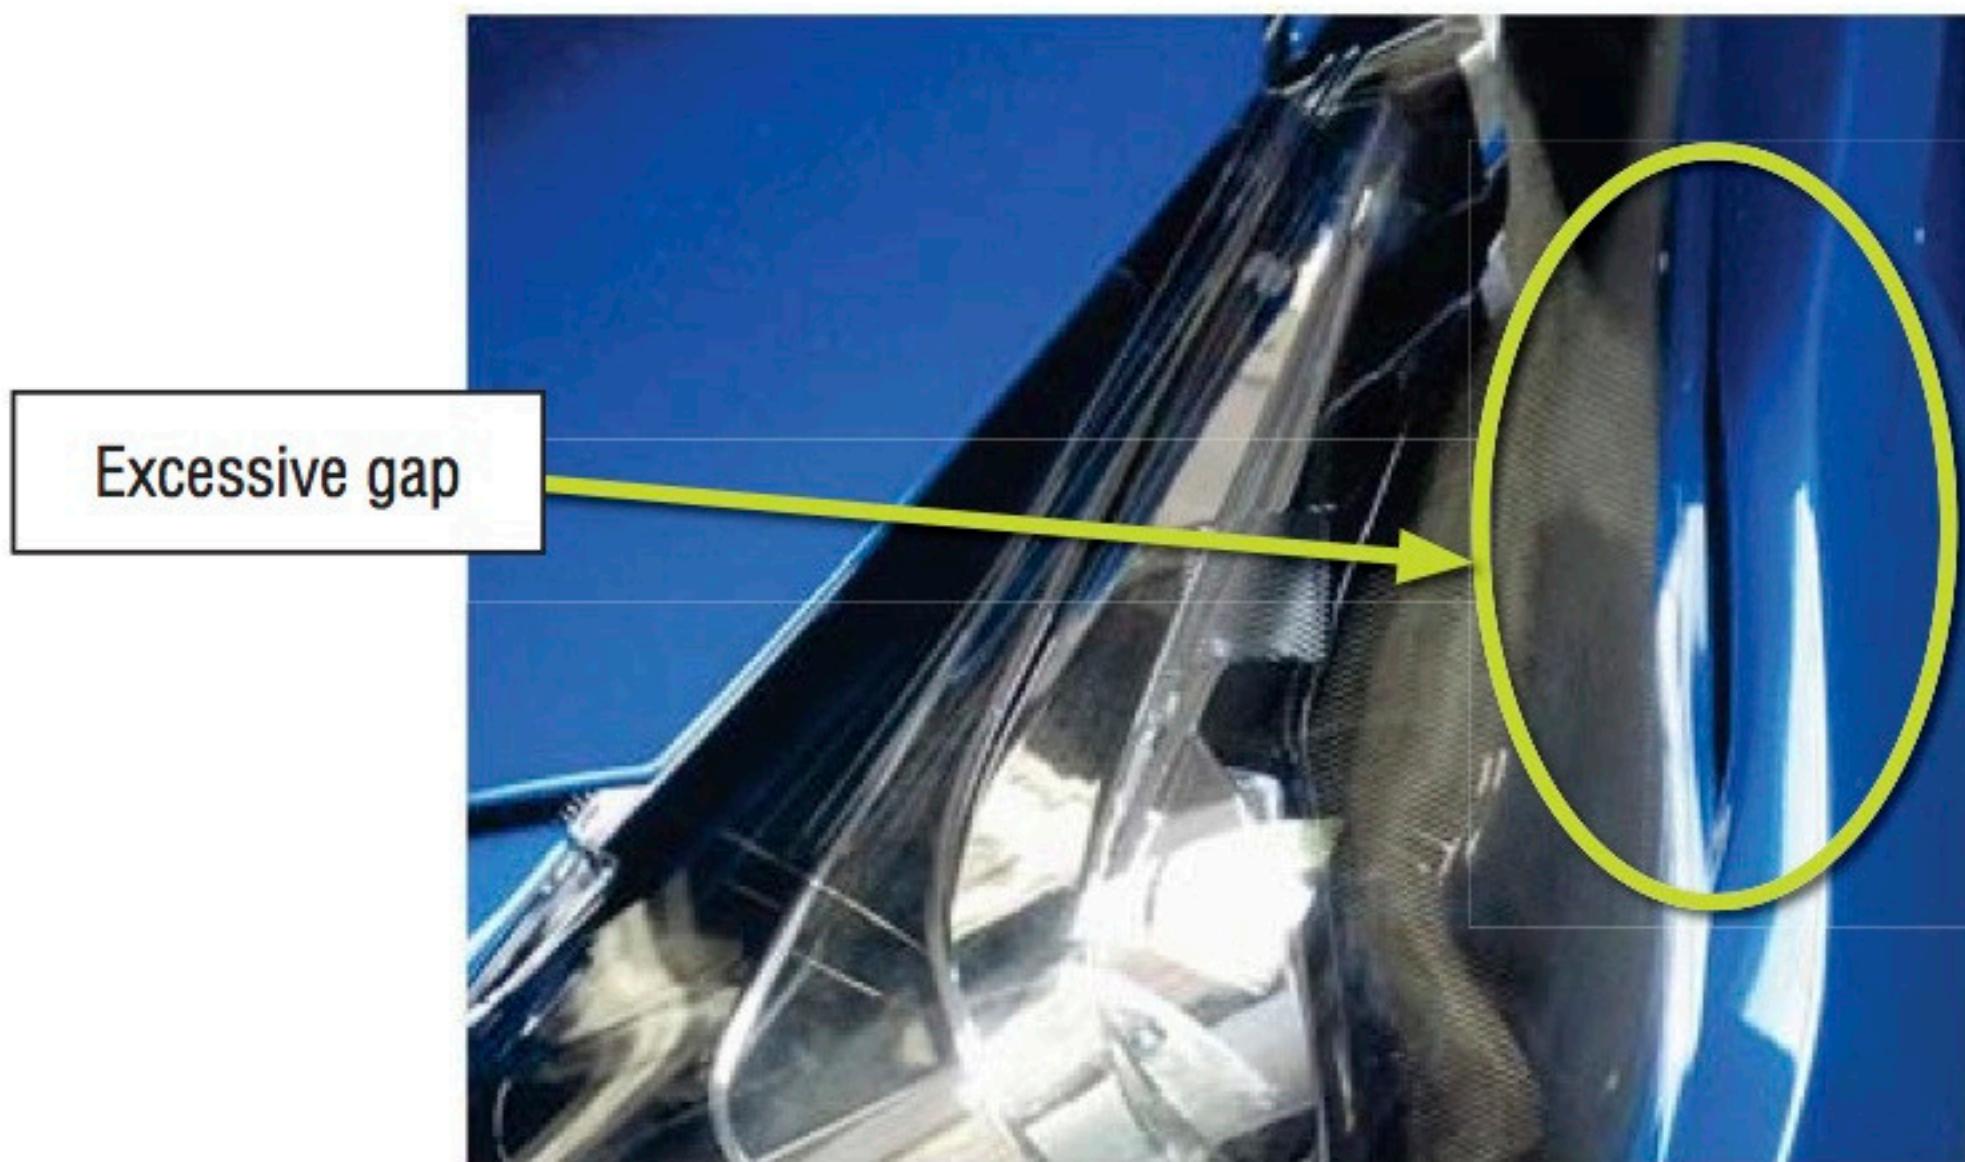
The photo below shows an excessive headlight gap which results when the alignment tab of the mounting bracket is not properly engaged into the alignment slot molded into the top rear edge of the bumper fascia.

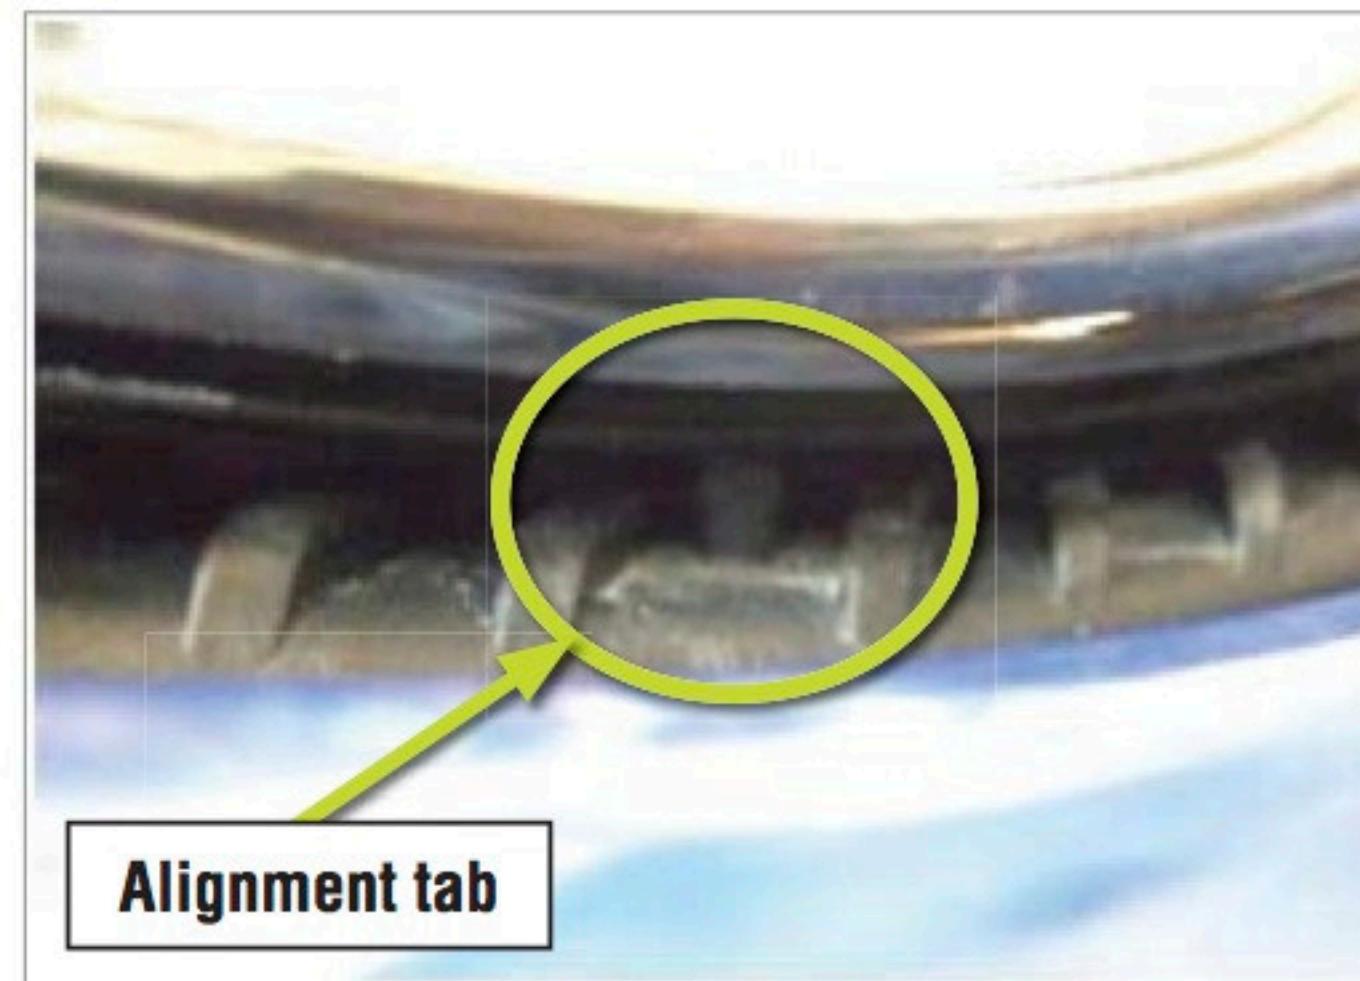
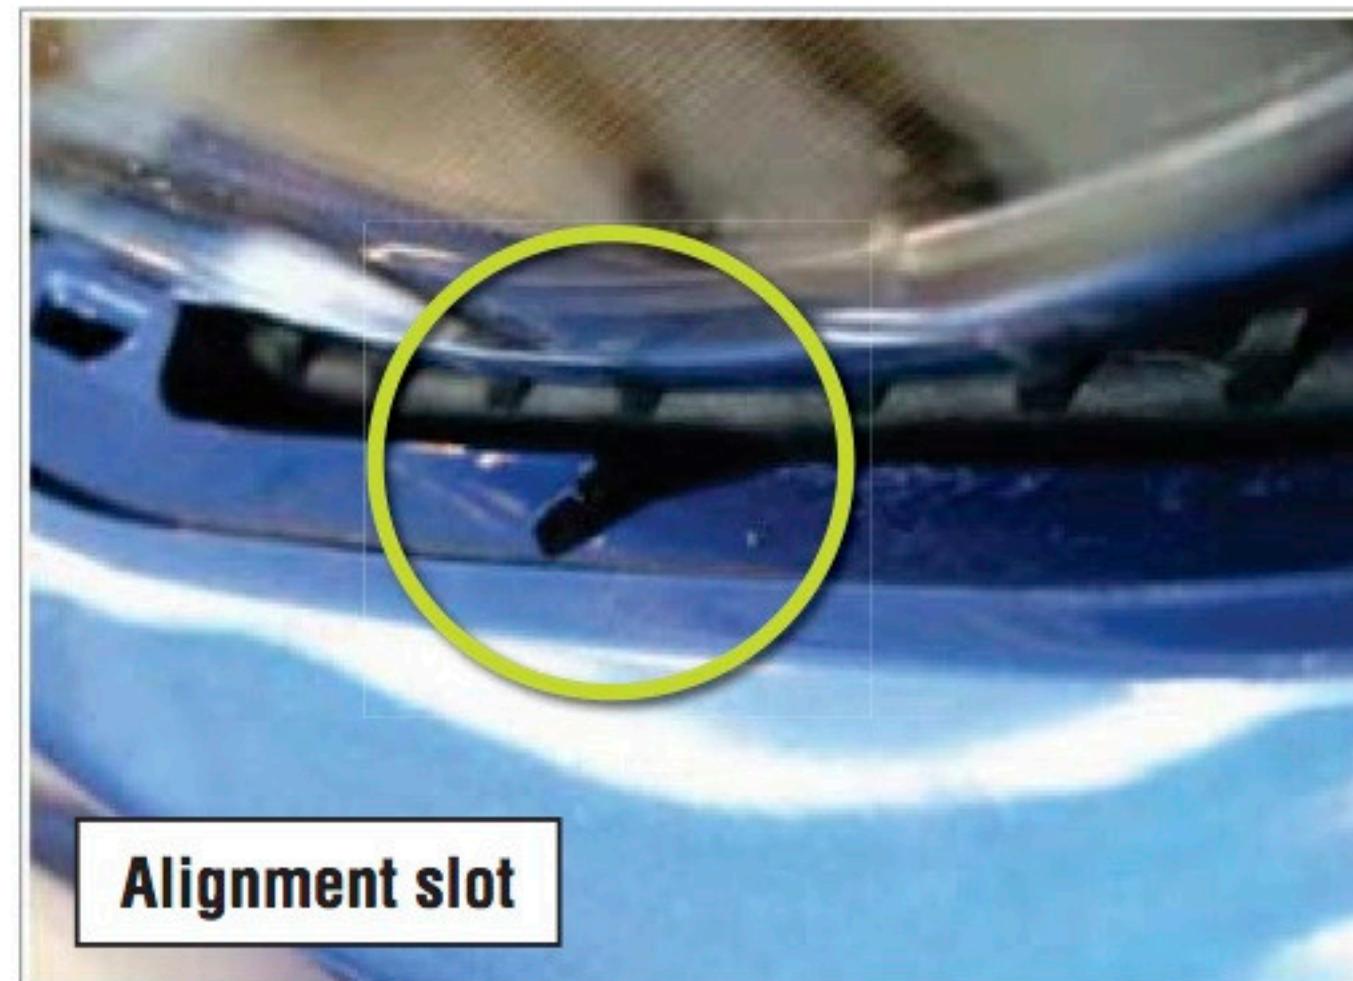
The middle photo above shows the alignment tab portion of the mounting bracket under the center of the headlight. The photo directly above shows the alignment slot which is molded into the rear edge of the bumper fascia. The tab must fit into the slot **completely** for proper fit and alignment.

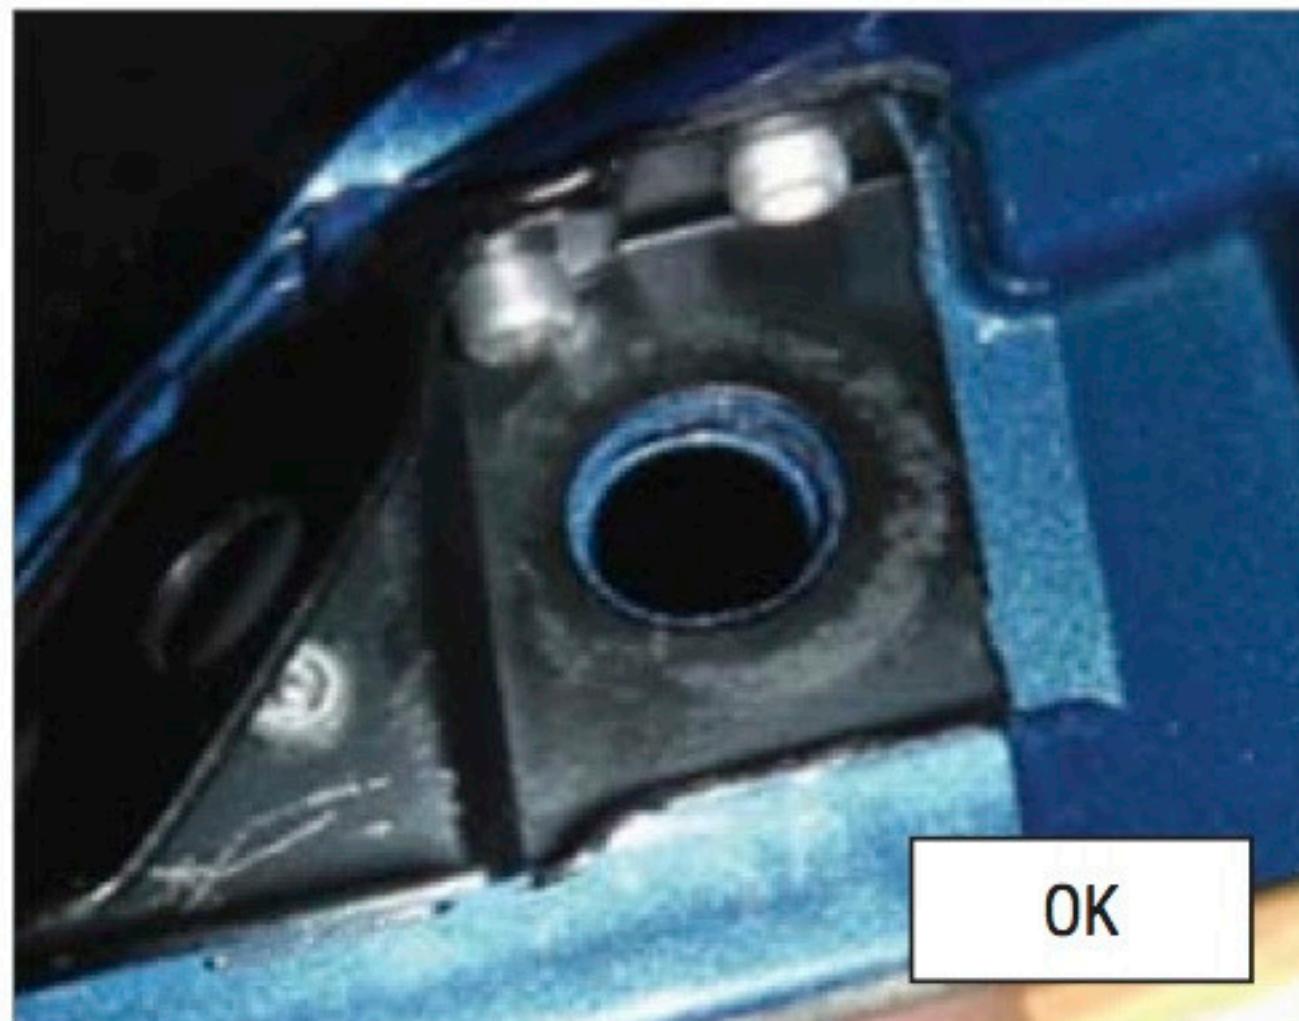
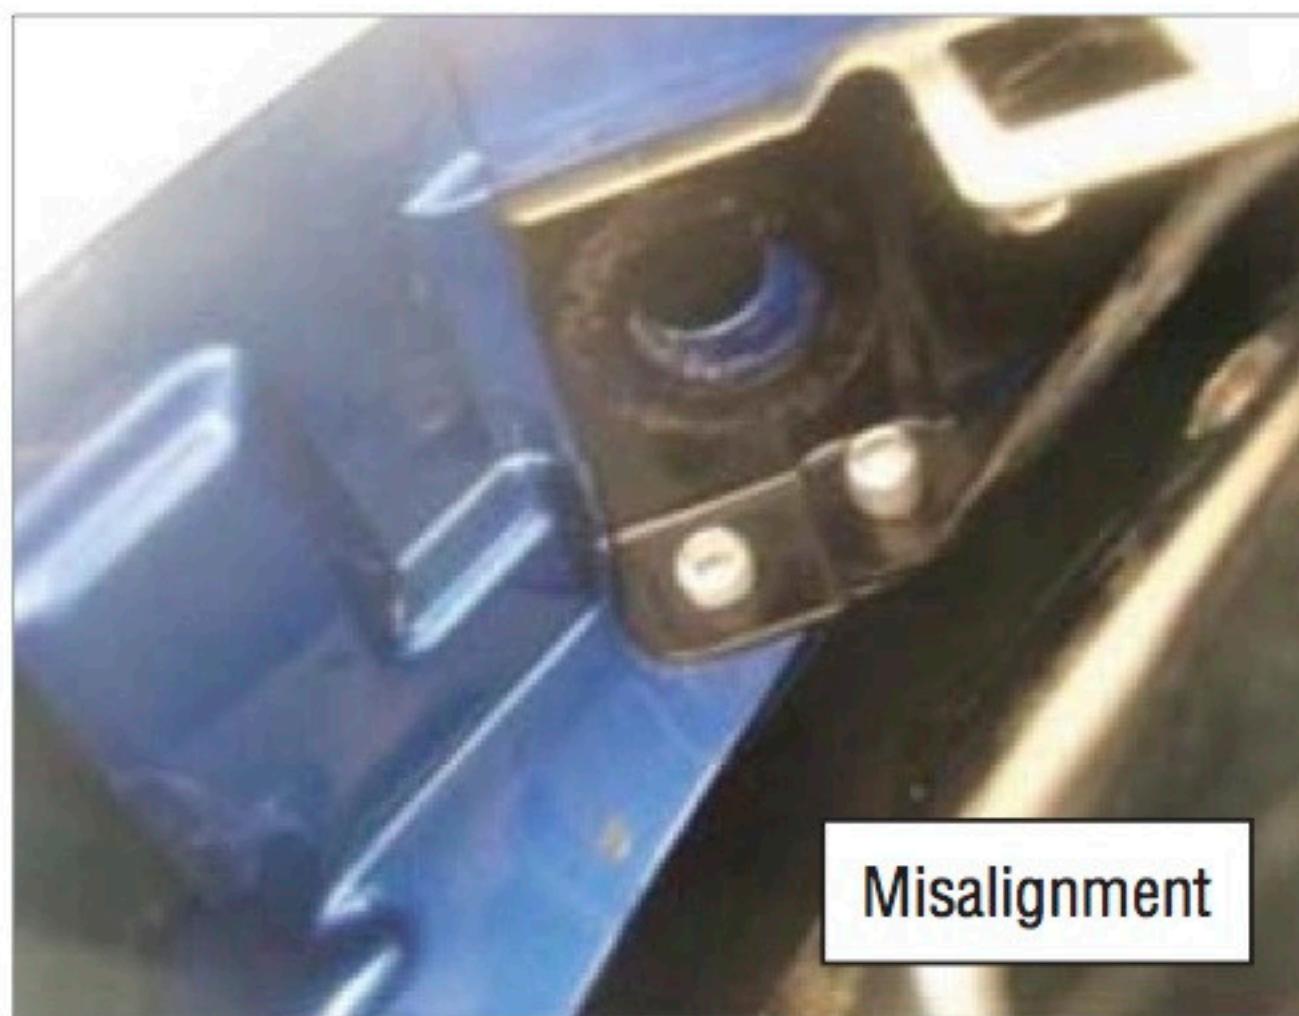
Looking up from below the fascia's rear attachment point, proper installation is confirmed when the holes the retaining clip fits into are all properly aligned as shown in top photo above. The photo directly above shows misalignment which is indication of an attachment point which is most likely still out of place. Keep in mind, there are three layers of material this retaining clip has to go through; first, the steel mounting bracket, the plastic bumper fascia itself and then the mounting flange of the fender.

After removal of the bumper fascia, inspect all the retention points for any indications of damage or distortion. Damaged or distorted retention points may not allow for sufficient retention and may require bumper fascia replacement. When re-installing the bumper fascia, start by confirming the tabs on the mounting brackets fit properly into the alignment slots on the rear edge as shown in the photos on pg. 2. Then, starting in the center of the vehicle, confirm proper engagement of all attachment points as you work your way around toward each side marker lamp.
