S-SB-0023-12

Abnormal Chirp or Squeak Noise from High Pressure Fuel Pump

YEAR(S)	MODEL(S)	ADDITIONAL INFORMATION
2013	FR-S

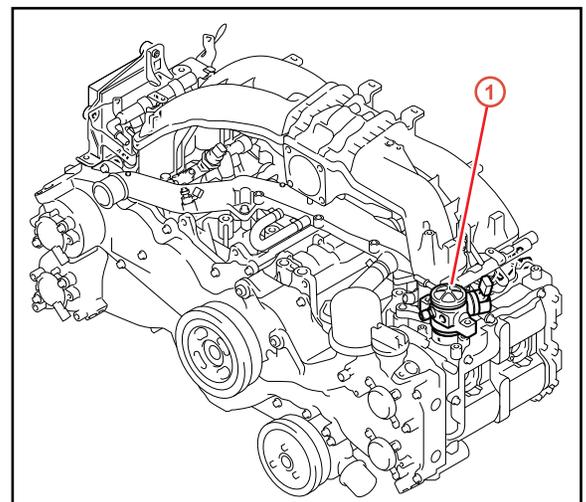
Figure 1.

1. Road test the vehicle for at least 10 minutes so that the engine is fully warmed up.
2. While the engine is idling, listen for abnormal noise from the High Pressure Fuel Pump Assembly.

- A mechanical ticking noise from the High Pressure Fuel Pump Assembly is normal during Direct Injection system operation.
- This bulletin should only be performed if an abnormal high pitch chirp or squeak noise from the High Pressure Fuel Pump is verified.

1	Fuel Pump Assembly (for High Pressure)
----------	---

4. Replace the High Pressure Fuel Pump Assembly.
