SERVICE BULLETIN

SUBARU CORPORATION
Customer Quality Dept.
Japan.

Issued: 9 March, 2022
Rev.1 25 July, 2022

Subject:	Repair Procedure Change: Repair Procedure against the squeaking noise from UNIVERSAL JOINT ASSEMBLY-STEERING
Applicable Section in Service Manual:	STEERING COLUMN > SYSTEM > Steering Intermediate Shaft Steering > POWER ASSISTED SYSTEM (POWER STEERING) > Universal Joint
Applicable Parts Name in Parts System:	Steering System and Cable > MANUAL STEERING GEAR BOX > UNIVERSAL JOINT ASSEMBLY-STEERING
Foreword:	This Service Bulletin is to inform you of the repair procedure against the squeaking noise from UNIVERSAL JOINT ASSEMBLY-STEERING that occurs when steering wheel is rotated. Rev.1: Added production change and new parts information.

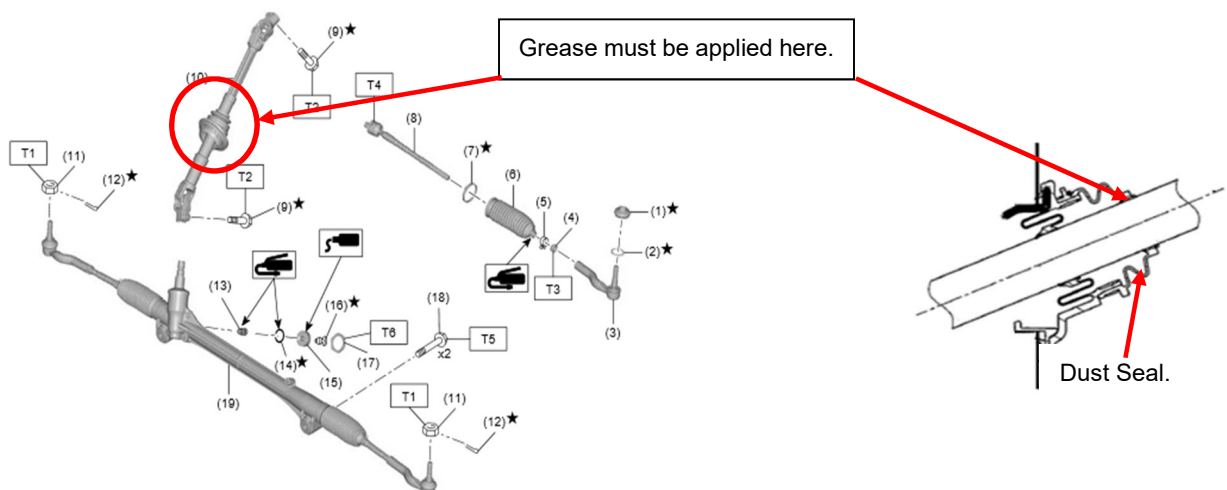
Symptom	Details of Symptom and Countermeasure
A squeaking noise occurs when steering wheel is rotated.	<p>Details of Symptom: A squeaking noise occurs from UNIVERSAL JOINT ASSEMBLY-STEERING when steering wheel is rotated. This is due to the lack of lubrication at the friction surface of the UNIVERSAL JOINT ASSEMBLY-STEERING dust seal. (Deteriorated grease created the lack of lubrication condition.)</p> <p>Countermeasure: The problem can be solved by adding 1-2 grams of grease to the UNIVERSAL JOINT ASSEMBLY-STEERING dust seal. For the production line, new UNIVERSAL JOINT ASSEMBLY-STEERING that contains new grease NIGLUBE RM inside is introduced.</p> <p>When the problem is reported, apply grease to the dust seal. (See 5. Working Procedure.)</p>

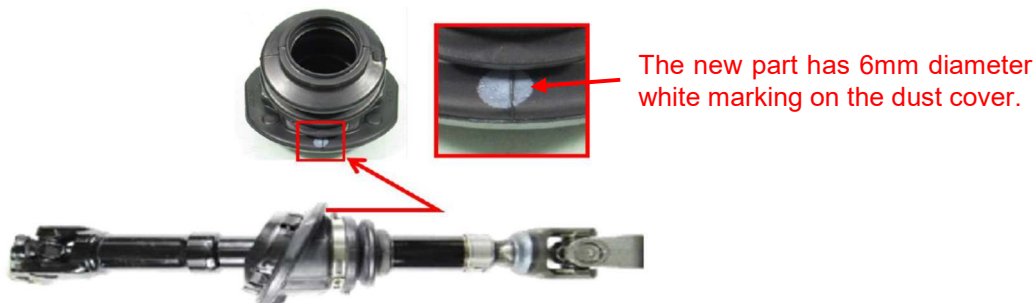
The old parts and new parts use different grease. (Old: NIGLUBE RX-2 New: NIGLUBE RM)
When lubrication the steering shaft, use appropriate grease. (Do not mix NIGLUBE RX-2 and NIGLUBE RM.)
See the below photos to identify old part or new part.
