SERVICE BULLETIN

APPLICABILITY: 2013MY BRZ

NUMBER: 07-68-12

SUBJECT: Alternate Procedure for Removal of Front Side Marker Lamp

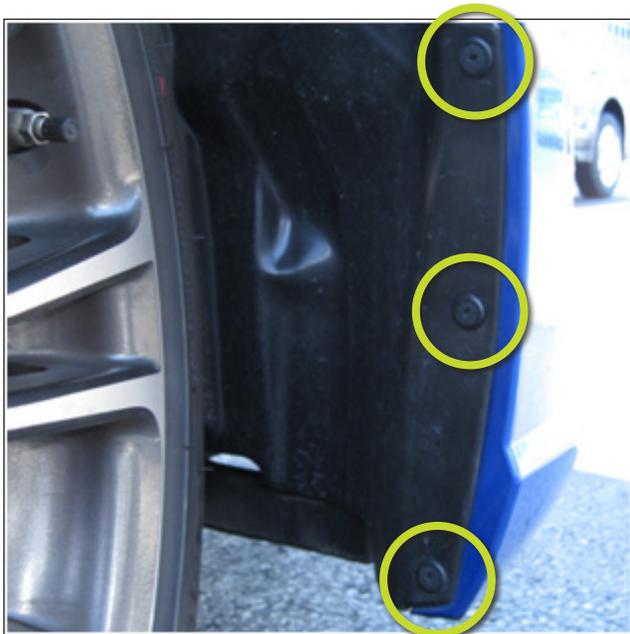
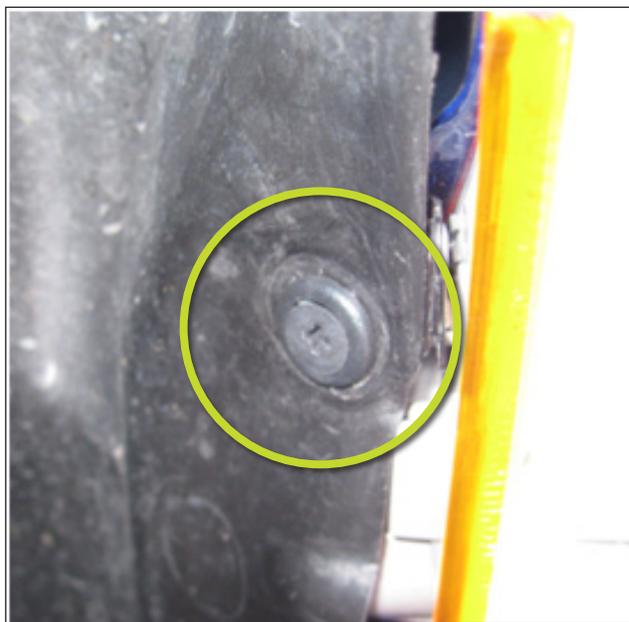
Most of the photos used in this bulletin were taken with the vehicle on a lift. With the suspension relaxed, there is more room available to access the inner fender liner retaining clips. In addition, turning the wheels to the right fully will provide more access to the left (Driver's) side inner fender area and vice-versa. Remove the 4 inner fender liner retaining clips shown in the photos below.

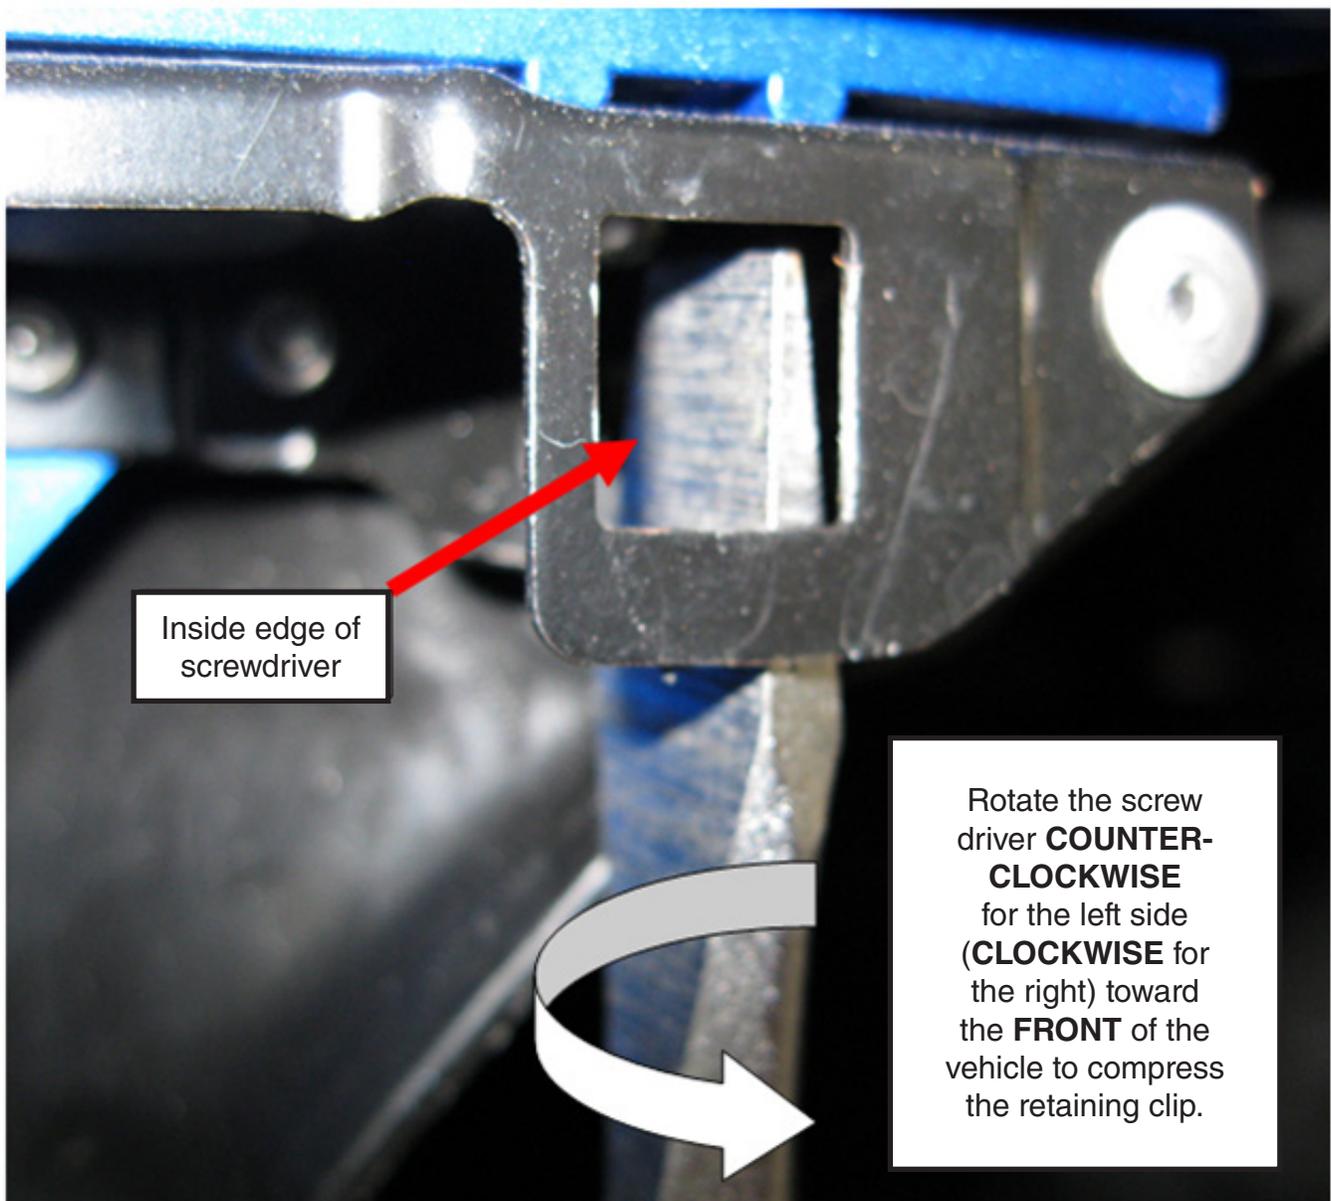
Once the 4 clips are removed, access the side marker lamp retaining bracket by moving the liner out of the way. The side marker lamp was removed for illustration purposes. The next photo shows the Driver's (Left) side marker light retaining bracket with a medium-sized flat-blade screwdriver inserted into the proper position prior to rotation to compress the side marker lamp's retaining clip. To release the left-hand (Driver) side retaining clip, slowly rotate the inside edge of the screw driver **COUNTER-CLOCKWISE** toward the front of the car. If turned in the opposite direction, the retaining clip will be damaged and likely not retain the lamp properly after re-installation. **CAREFULLY** turn the screw driver with one hand while pulling outward on the top of the lamp slightly with the other to help with the release. It is important to **TAKE YOUR TIME** and not compress the retaining clip any further than necessary or its ability to properly retain the lamp upon reassembly may be lost. **REMINDER:** The retaining clips are part of the lamp assembly and not available separately.

The purpose of this bulletin is to provide an alternate procedure for removal of the front side marker lamp assembly. Although this procedure differs slightly from the recommended method outlined in the Service Manual, we have found it reduces the potential for damage to the lamp's retaining clips which can result in a loose fit upon re-installation. The key is to not use any more force than necessary to compress the spring clips used to retain the lamp assembly to its mounting bracket while simultaneously pulling outward lightly on the lamp. If the retaining clips are damaged or lose their tension, the lamp assembly will need to be replaced as the clips are not available separately.

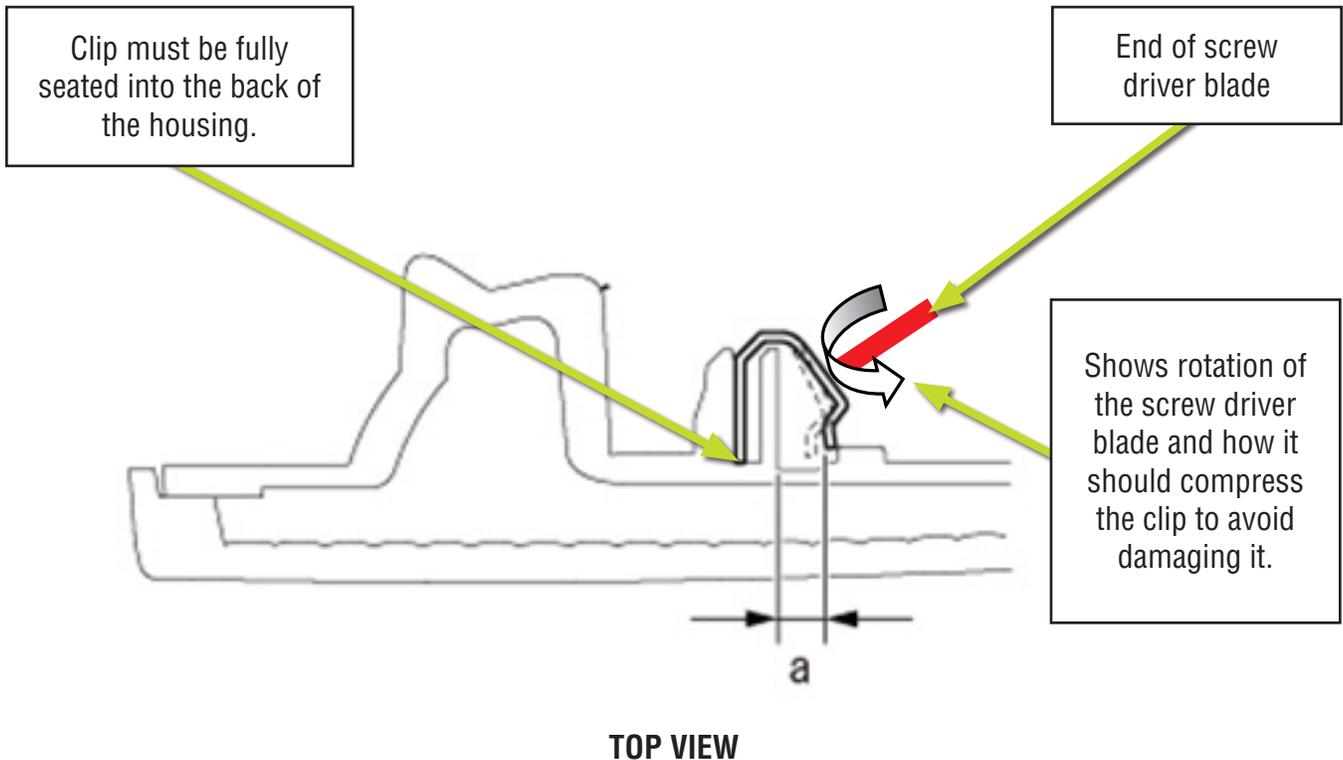
The illustration below provides another view of the lamp and additional clarification of how to compress the retaining clip. Before re-installing the lamp assembly, confirm the bulb operates normally. Next, confirm the retaining clips are fully inserted into their proper positions on the back of the housing and the gap measures 3mm (.118") as shown in the below illustration (a). If the end gap on the clip is less than 3mm, the side marker lamp will not be secured properly in the retaining bracket and feel like it is loose. Use needle-nose pliers to adjust the end gap if necessary. If the clip breaks, loses its tension, gets sprung up away from the lamp body or becomes dislodged, the lamp assembly will need to be replaced. In addition, be sure to straighten any deformation and touch up any scratches which may have occurred to the lamp mounting bracket during the side marker removal process.

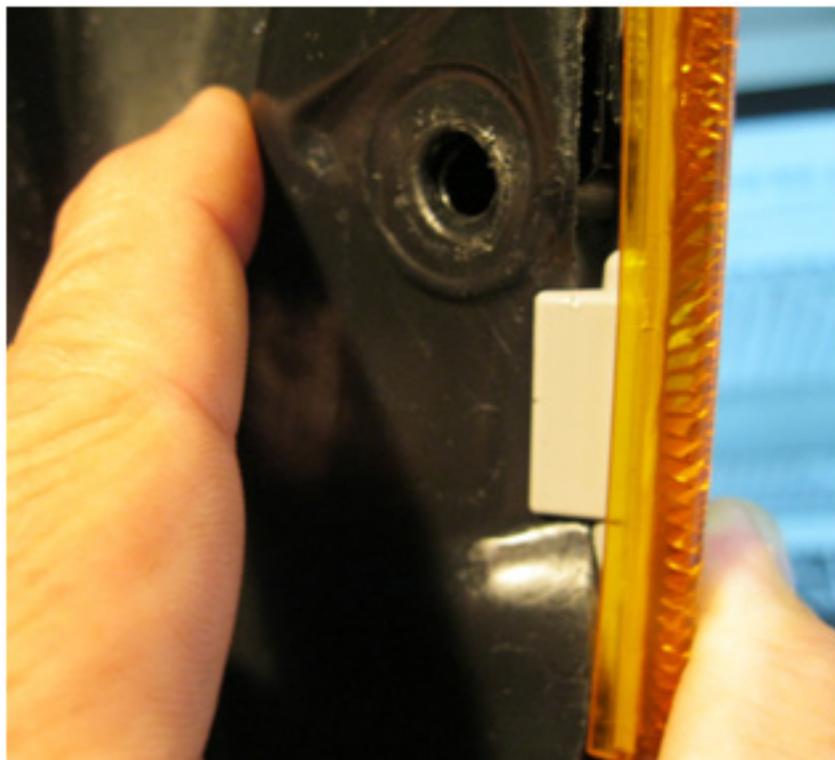
After the lamp is re-installed into the mounting bracket, refit the inner fender liner. NOTE: The liner must fit behind the tab molded into the base of the marker light assembly as shown in the photo below. To complete the procedure, confirm the liner is fully seated behind the fender lip the rest of the way around the wheel arch to keep water from getting behind it then install the 4 retaining clips.
