Moisture in Rear Combination Light / Water Intrusion Into Vehicle

YEAR(S)	MODEL(S)	ADDITIONAL INFORMATION
2013	FR-S

Introduction

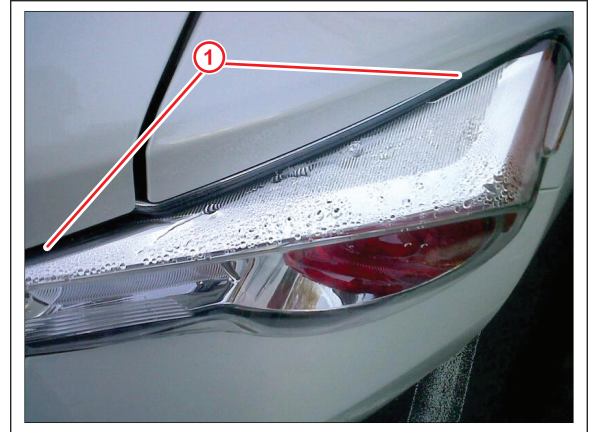
Figure 1.

1. Prior to making any repairs or replacing parts, locate the source of water entry.
2. See Figure 1 for an example of moisture inside the Rear Combination Light.

1 Interior Moisture

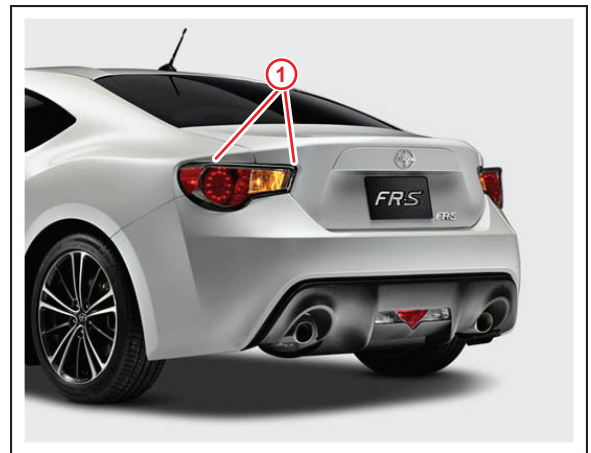
Figure 2.

4. Spray water on the vehicle, especially around the perimeter of the light housing.

1 Spray Location

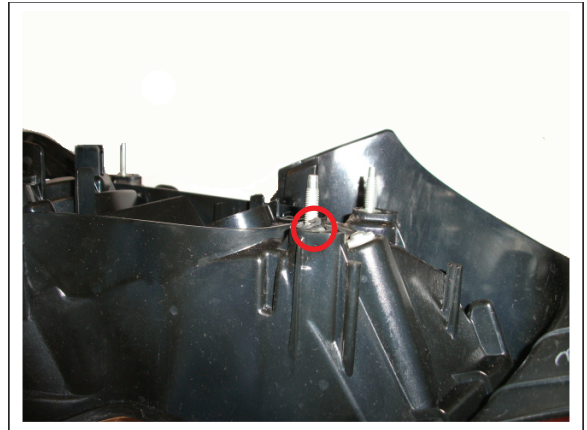
Figure 3.

6. Remove one or both lights that show evidence of moisture intrusion.
7. Inspect the back side of the combination lights for evidence of plastic cracking around the mounting studs. If cracking is present, replace the housing and the gasket.

The sealing gasket is a “ONE USE ONLY” type gasket and **MUST** be replaced every time a combination light housing is removed from the vehicle.

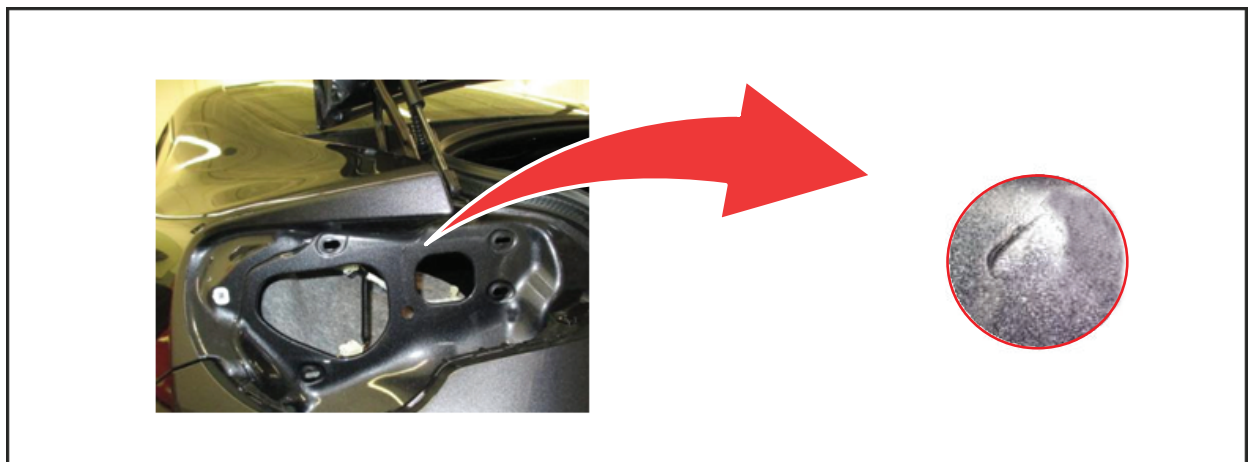
Figure 4.

1. Inspect the sheet metal body panel adjacent to the back side of the light housing for evidence of misplaced body seam sealer.

Remove any misplaced seam sealer with the sharp end of the plastic pry tool (SST# 00002-06002-01) being careful NOT to damage the painted body surface. If bare metal should appear during the sealer removal process, use touch-up paint to cover any bare metal areas before proceeding.

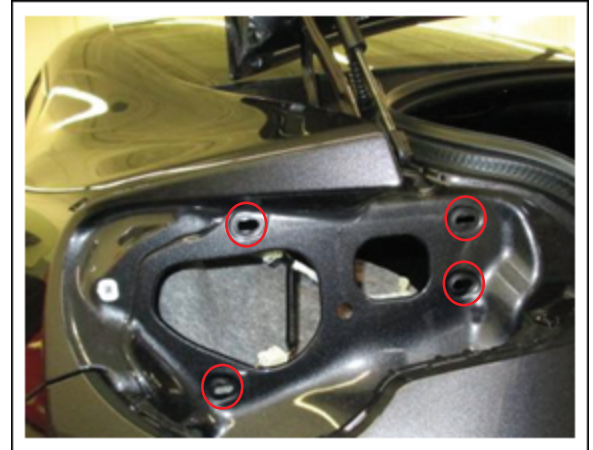
Figure 5.

2. Inspect the body sheet metal for evidence of deformed (cone shape) sheet metal around the 4 through-holes in the body.

Use a Body Hammer and Body Dolly to flatten the sheet metal around the 4 through-holes in the body (see circled areas for through-hole locations). Use touch-up paint on any bare metal areas.

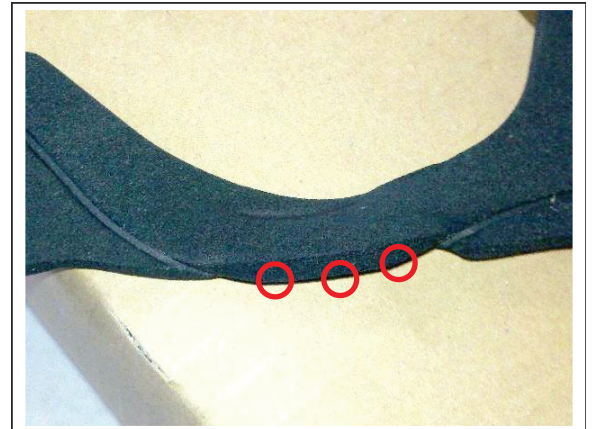
Figure 6.

3. Inspect the rear combination light sealing gasket for evidence of misplacement.

A misplaced gasket may allow water to enter the combination light housing or possibly the interior of the vehicle.

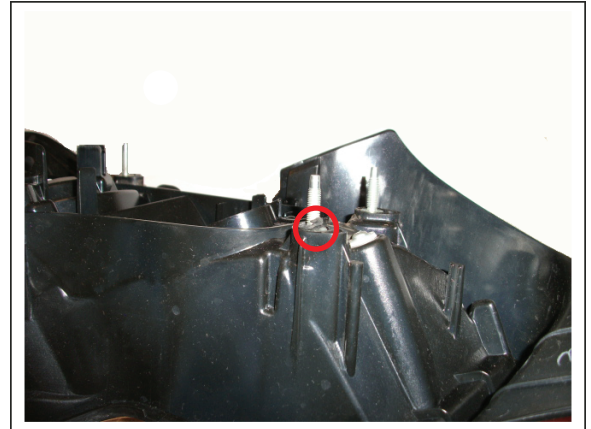
Figure 7.

4. Replace a rear combination light ONLY if it is damaged.

- If the cause of the water leak was misplaced seam sealer or a misplaced sealing gasket, carefully inspect the combination light housing for evidence of damage and if no damage is present, do NOT replace the housing, replace ONLY the sealing gasket.
- The sealing gasket is a “ONE USE ONLY” type gasket and **MUST** be replaced every time a combination light housing is removed from the vehicle.

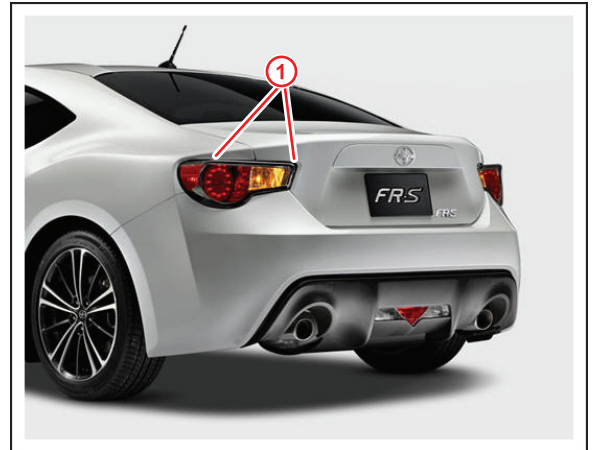
Figure 8.

7. Perform a final water test confirmation.
 - A. Spray water on the vehicle, especially around the perimeter of the light housings.
 - B. From inside the vehicle, confirm there is no water is leaking into the vehicle.
