Abnormal Chirp or Squeak Noise from High Pressure Fuel Pump

Service Category Engine/Hybrid System

Section Fuel System

YEAR(S)	MODEL(S)	ADDITIONAL INFORMATION
2013	FR-S

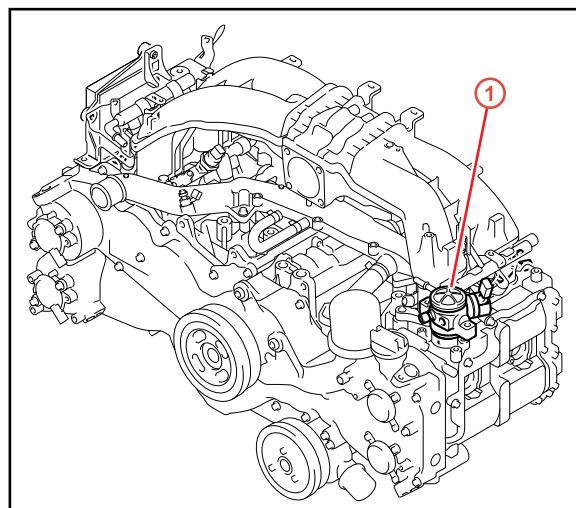
Figure 1.

Some vehicles may exhibit a high pitch chirp or squeak noise from the High Pressure Fuel Pump Assembly when the engine is fully warmed up and idling. Follow the procedure in this bulletin to address this condition.

- A mechanical ticking noise from the High Pressure Fuel Pump Assembly is normal during Direct Injection system operation.
- This bulletin should only be performed if an abnormal high pitch chirp or squeak noise from the High Pressure Fuel Pump is verified.

1 Fuel Pump Assembly (for High Pressure)

4. Replace the High Pressure Fuel Pump Assembly.
