Abnormal Chirp or Squeak Noise from High Pressure Fuel Pump

Service Category Engine/Hybrid System

Section Fuel System

YEAR(S)	MODEL(S)	ADDITIONAL INFORMATION
2013 – 2014	FR-S

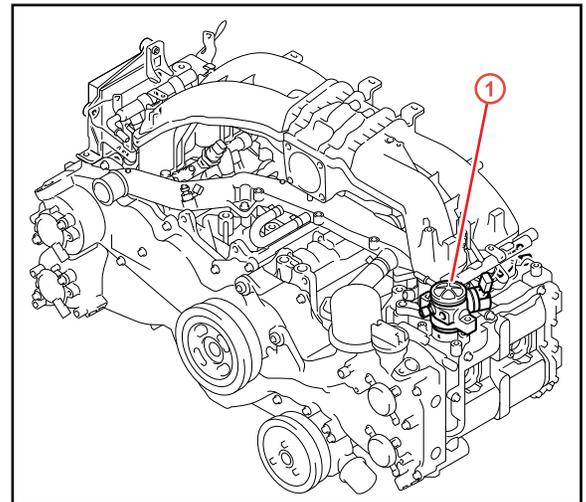
Figure 1.

1. Road test the vehicle for at least 10 minutes so that the engine is fully warmed up.
2. While the engine is idling, listen for abnormal noise from the High Pressure Fuel Pump Assembly.

1	Fuel Pump Assembly (for High Pressure)
----------	---

4. Replace the High Pressure Fuel Pump Assembly.
