Window Freezing, Losing Initialization

Service Category Vehicle Exterior

Section Window/Glass

YEAR(S)	MODEL(S)	ADDITIONAL INFORMATION
2013	FR-S

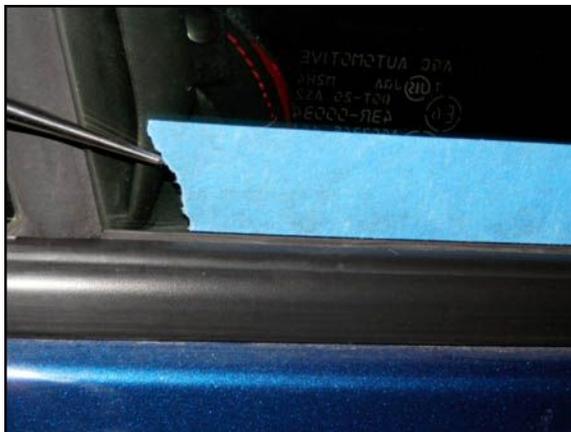
Figure 3. Example of Tape Applied to Front of Outer Door Weatherstrip

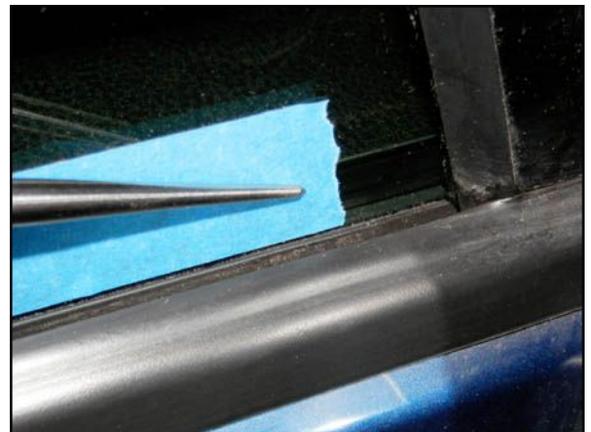
Figure 4. Example of Tape Applied to Rear of Outer Door Weatherstrip

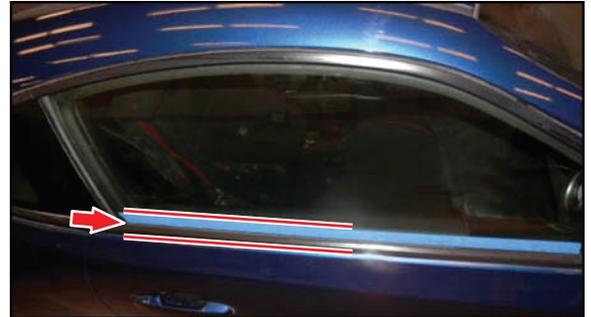
Figure 5. No Gap Between Tape and Outer Door Weatherstrip

- There should be no gap between the outer Door Weatherstrip and tape.
- If the window was not properly aligned prior to this repair, the procedure will not be successful.

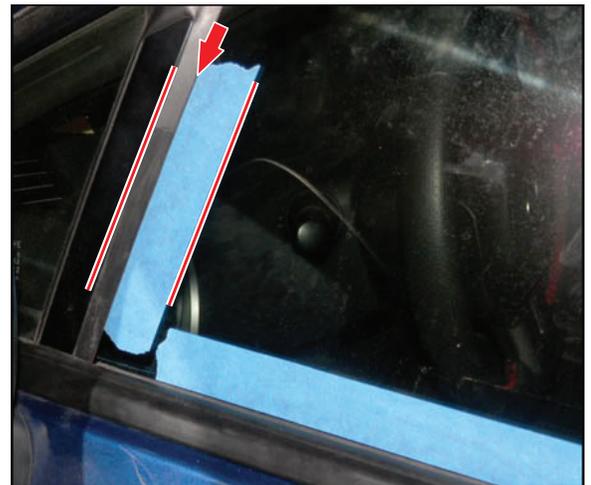
Figure 6. No Gap Between Tape and Outer Door Weatherstrip

- D. Apply a strip of 3M™ ScotchBlue™ Painter's Tape (or equivalent) vertically on the glass, parallel and adjacent to the front weatherstrip. There should be no gap between the weatherstrip and tape.

The tape should extend within 2 inches (or closer) to the top and bottom of the glass. This will aid in aligning the window during installation.

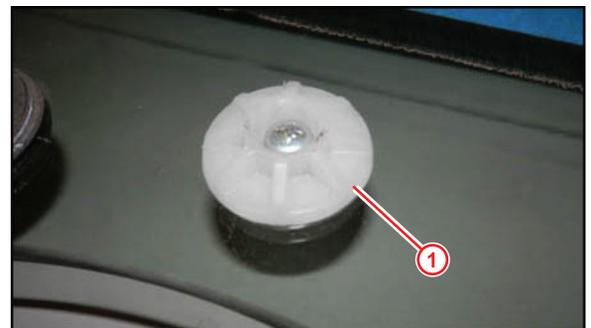
Figure 8.

1	Glass Lifter
----------	---------------------

3. After the glass assemblies have been removed, carefully remove the 2 (white) door glass window lifters from the driver and passenger side glass.

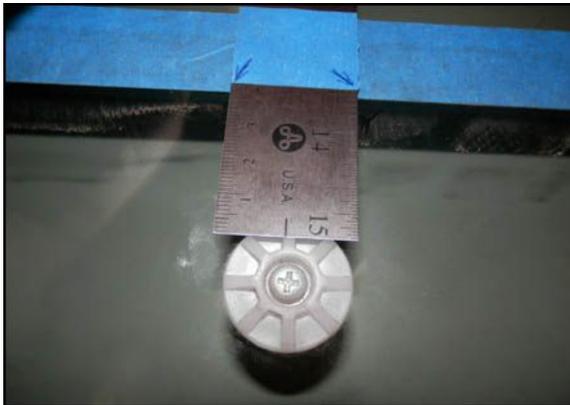
Figure 9. Edge of Ruler Against Flat Side of Glass Lifter

- Using a ruler as a guide, install the NEW Glass Lifters. Ensure the flat edge at the top of the Glass Lifter is facing the top of the glass and is parallel to the masking tape on the glass as shown below.

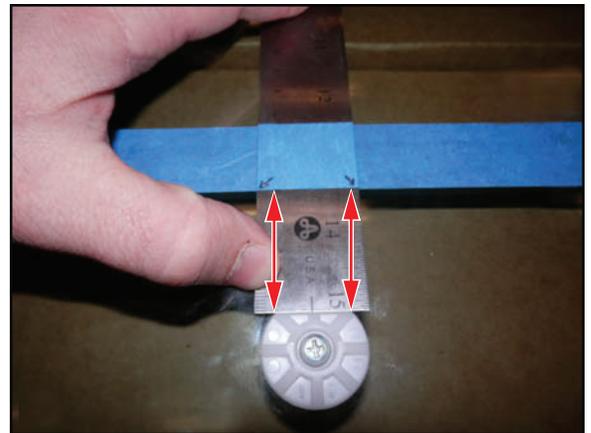
Figure 10. Edge of Ruler Parallel to Tape

- Be sure the flat edge on the Glass Lifter is parallel to the tape applied in earlier steps. If necessary, loosen and realign the Glass Lifter to ensure it is parallel to the tape.
- If new nuts are not available to install the window to the regulator, use Toyota Genuine Adhesive 1344, Three Bond 1344, Loctite® 242, or equivalent, to reinstall the nuts.

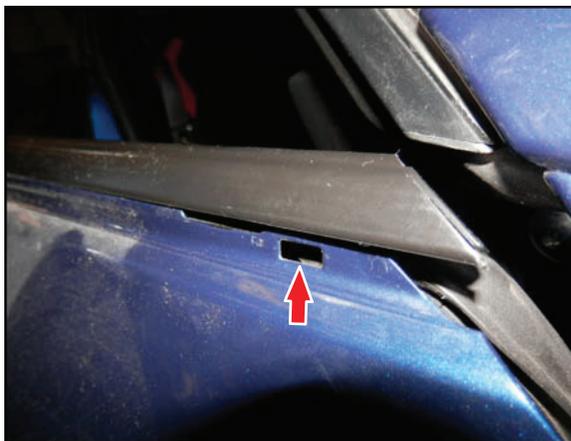
Figure 11. Hole for Clip in Outer Door Weatherstrip at Front of Door

1. Ensure the bolt holding the outer Door Weatherstrip is removed.
2. Disengage the clip holding the weatherstrip.
 - A. At the front of the door is a hole where the clip is engaged. Use a plastic pry tool to gently pry out and up on the weatherstrip in this location at the front of the door. This will allow the clip in the weatherstrip to disengage.
 - B. After disengaging the clip, lift up on the outer Door Weatherstrip starting where the bolt is.
