Idle Fluctuation in Park or Neutral

Service Category Engine/Hybrid System

Section **Market** USA

YEAR(S)	MODEL(S)	ADDITIONAL INFORMATION
2015 - 2016	FR-S

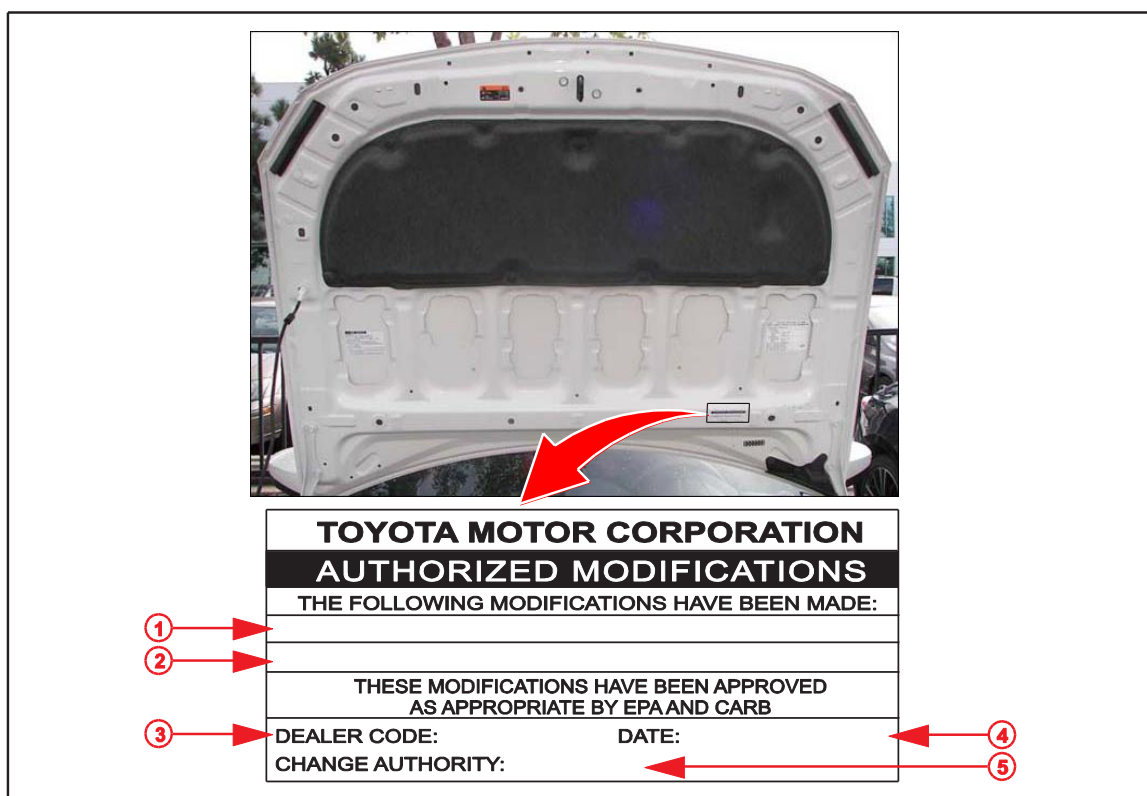
Figure 1. Location of Authorized Modification Label on 2015 FR-S

1	Replacement TCM Part Number (i.e., SU003-05270)
2	New Calibration ID(s) (i.e., AQF5DCB0)
3	Dealer Code

4	Date Completed
5	This SB Number

1. Confirm the condition as described in the Introduction.
2. Confirm calibration applicability.
3. Reprogram the TCM.
 - A. Check for the Authorized Modifications Label affixed to the vehicle in the location shown in Figure 1. Confirm if the TCM calibration has been updated. If the calibration ID listed is NOT the latest TCM calibration - go to step 3.B.

(2) Affix the Authorized Modifications Label to the vehicle at the location shown in Figure 1. The Authorized Modifications Label is available through the MDC, P/N 00451-00001-LBL.
