SERVICE BULLETIN

SUBARU CORPORATION
Customer Quality Dept.
Japan.

Issued: Feb. 23, 2023

Subject:	Part Change Information: New Part GLASS-FRONT DOOR,PARTITION,RIGHT/LEFT as countermeasure against wind noise problem on BRZ
Applicable Section in Service Manual:	Body & Electrical/WIRING SYSTEM > GLASS/WINDOWS/MIRRORS > Front Door Glass
Applicable Parts Name in Parts System:	Door, Seat, Windshield and Instrument Panel > DOOR PARTS (GLASS & REGULATOR) > GLASS-FRONT DOOR,PARTITION,RIGHT/LEFT
Foreword:	This Service Bulletin is to inform you of the new GLASS-FRONT DOOR, PARTITION,RIGHT/LEFT as countermeasure parts against the wind noise problem that comes from front door partition glass area.

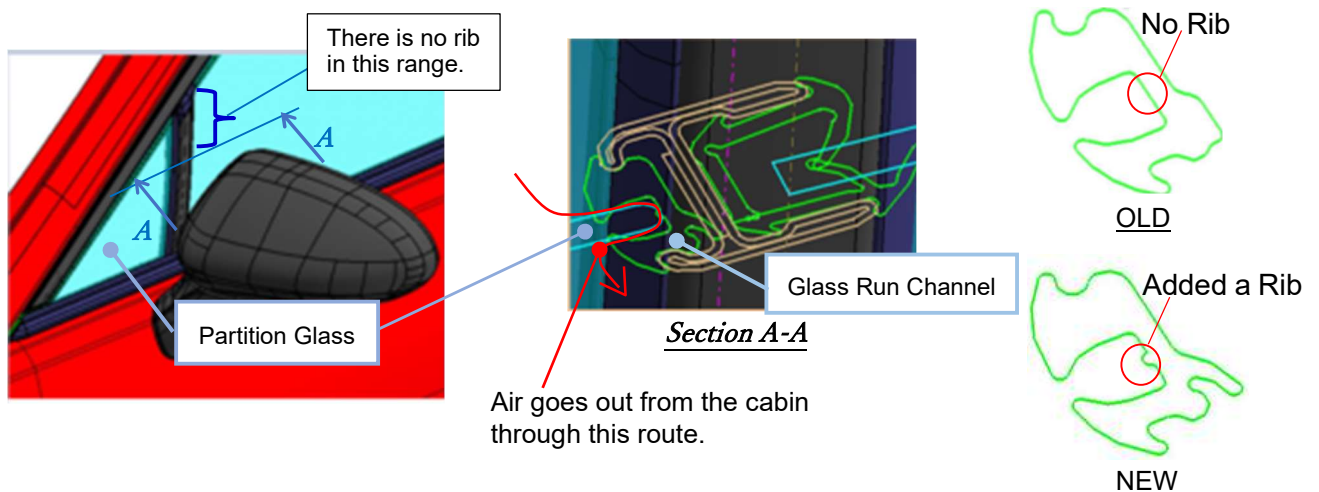
Phenomenon	Details of the Symptom and Improvement
Wind noise comes from front door partition glass area while driving.	<p>Details of the Symptom: Wind noise comes from front door partition glass area while driving. This is due to the excessive clearance between the partition glass and the glass run channel. (The wind noise occurs when air goes out from the cabin through the clearance.)</p> <p>Improvement: Added a rib to the glass run channel to eliminate the excessive clearance between the partition glass and the glass run channel.</p> <p>If the problem is reported, check if the noise comes from the partition glass area by following the test procedure in the next page first. If the test result shows that the noise comes from the partition glass area, replace GLASS-FRONT DOOR, PARTITION, RIGHT and/or LEFT with the countermeasure one(s).</p>

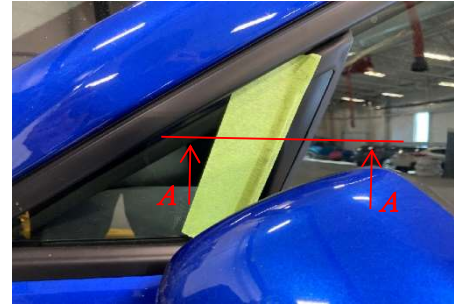
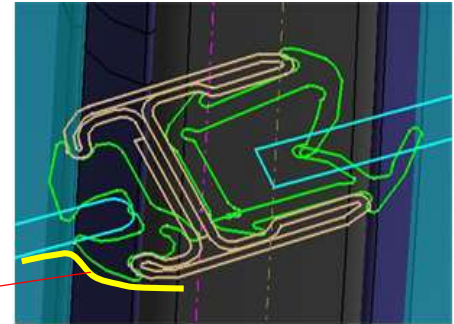
Masking Tape

Section A-A

- Put a masking tape on the partition glass and the glass run channel as shown in the photo.
- Drive the vehicle and check if the noise is gone.
- If the noise is still there, noise source is not partition glass or glass run channel. Diagnose the other source.
- If the noise is gone, the source of the noise is the excessive clearance between partition glass and glass run channel.
Replace GLASS-FRONT DOOR, PARTITION, RIGHT and/or LEFT with the countermeasure one(s).
(Replace the part on the noisy side only.
No need to replace the no noise side.)
