# SERVICE BULLETIN

**SUBARU CORPORATION**  
Customer Quality Dept.  
Japan.

| Subject: | <b>Part Change Information:<br/>New Part "POCKET ASSEMBLY" for BRZ</b> |

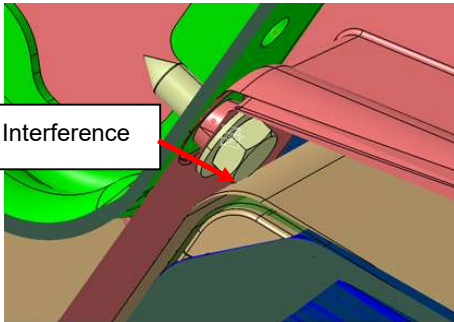
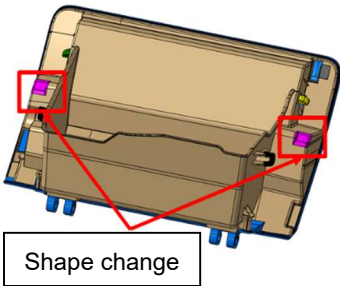
| Symptom | Details of the Symptom and Improvement |
|---|---|
| POCKET ASSEMBLY interferes with instrument panel installation bolt and gets scratched. | <p><b>Details of the Symptom:</b><br/>If POCKET ASSEMBLY of glove box is shut strongly or pressed forward hardly, it interferes with the instrument panel installation bolt, creating scratch marks on the POCKET ASSEMBLY.</p> <p><b>Improvement:</b><br/>As a countermeasure, the shape of POCKET ASSEMBLY was changed to avoid the interference between POCKET ASSEMBLY and instrument panel installation bolt.</p> <p>If the problem is reported in the field, replace POCKET ASSEMBLY with the new one.</p> |

| No. | New Parts | | Interchangeability | Old Parts | Note |
|---|---|---|---|---|---|
| 1 | Part No. | 66121CC011 | New Part to Old Vehicle: <b><u>Yes.</u></b><br>Old Part to New Vehicle: <b><u>No.</u></b> | 66121CC010 | North America |
| 2 | Part No. | 66121CC021 | New Part to Old Vehicle: <b><u>Yes.</u></b><br>Old Part to New Vehicle: <b><u>No.</u></b> | 66121CC020 | Europe General |
